ENVIRONMENTAL PROTECTION AGENCY

Refer to: L1631210001 -- St. Clair County
Sauget & Company Landfill (Site Q) -- Sauget
Superfund/Compliance

Sampling Locations and Rationale

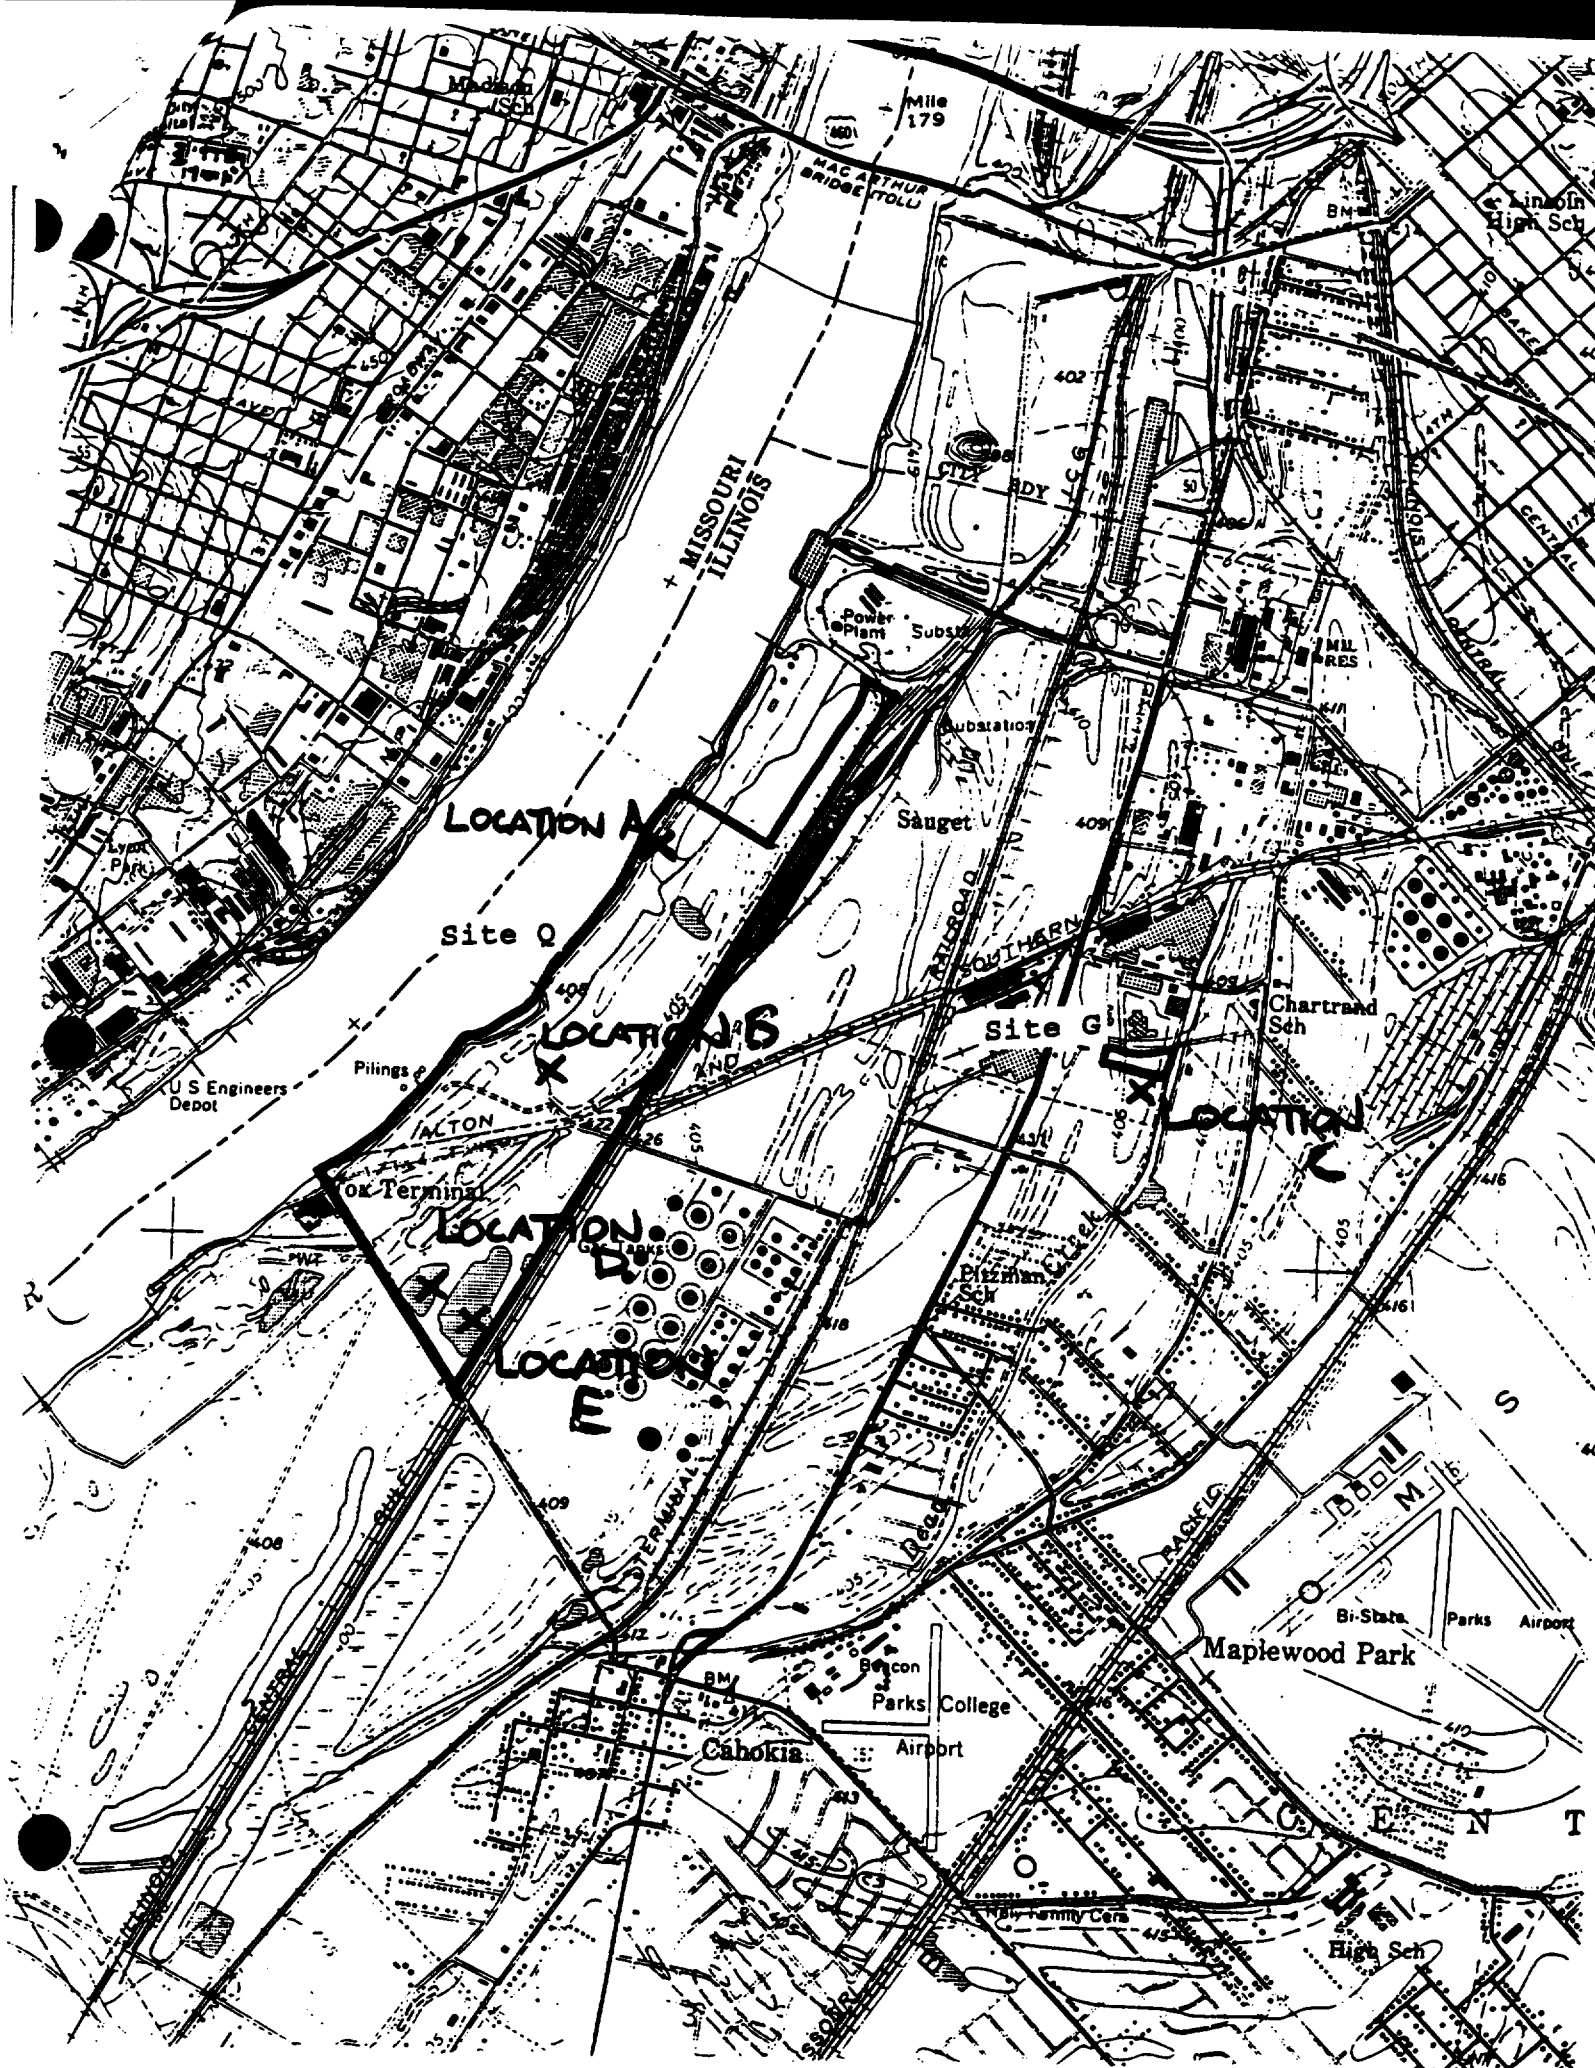
Five general locations that are proposed for sampling are noted on the map of the following page. The number of samples for each location and rationale are mentioned below:

Location A - Two samples of waste materials found in several corroding drums. These drums are located about 300 feet south of Site R along the bank of the river. The waste materials appear to be inert with no unusual volatile vapors. Strong organic odors are periodically noted in the vicinity, but it is not known if they are coming from Site R or an unknown leachate seep along the river bank. The waste materials in the drums, which have never been sampled, were evidently disposed of with broken concrete and cinders and were present before the flood.

Location B - One sample in an isolated location at the south central portion of Site Q. The immediate vicinity shows stressed vegetation. Several blocks of a yellowish material resembling sulfur that has been seen at Site G and the borrow pits at the south end of this site were noted.

Location C - Two samples in a low-lying area to the south of Site G. This swampy area was impacted by high water table conditions that persisted during and shortly after last years flood. The rationale of sampling at this location is based on its proximity to very high levels of contaminants at the surface of Site G and the fact that contaminated sediment has likely been deposited into this area for years. Recent sampling results and activities associated with putting out underground fires at Site G have made knowing what may be present in sediments here a higher priority.

Location D - Four samples in the "southwest borrow pit". The Ecology & Environment report (1988) did not investigate a waste pile and a few drums of waste materials that were present in a low-lying area that is usually submerged. The waste pile contains a black oily material, blocks of yellow and dark grey crystalline substances and rubber gaskets. There are also drums present around the margins of the pit that should be sampled.

Location E - Seven samples in the larger "southeast borrow pit". As was the case at Location D, this area was never sampled. When the site was discovered three years ago, several corroded drums and waste materials were noted in piles and along ridges of this borrow pit. The grayish crystalline materials noted above are present, but in greater quantities. A very large pile of rusting drums and waste materials is present at the west-central portion of the pit and a ridge of waste materials is present in the north-central portions. Limited sampling around this pit has showed PCBs to be present in the 10-20ppm range.
